**Flood Control Project Maintenance
Levee Inspections**

Maintenance Issue Types Only, Levee Inspection Report By Mile - Spring 2016

Reclamation District No. 2031 Elliot

Waterway	Bank	Unit Miles	Inspection Start/End	Inspector
Unit No. 01 Stanislaus River	Left	7.07	03/30/2016 03/30/2016	Maksim Khashchuk

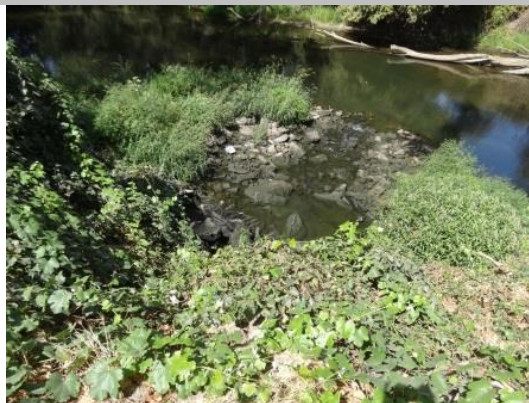
Photo 1 of 3 : SP_2016_RD2031_307_1_20160229_00001.jpg

08/28/2015: No significant change observed.
 07/31/2014: No significant change observed.
 09/10/2013: No significant change observed.
 07/18/2012: No significant change observed.
 08/18/2011: No significant change observed on site. Debris that blocks the irrigation outlet is visible.
 10/19/2010: No significant change observed on site. Sloughing of the bank is occurring adjacent to an irrigation outlet structure. There is moderate to heavy vegetation along the bank that is well established. Broken chunks and slabs of concrete are used as rip rap and line the outside of the irrigation outlet structure. However, much of the rip rap along the slope is sloughing and could possibly lead to future slope instability.
 08/05/2010: Recommended as a local maintenance issue, per CLRO.
 08/20/2009: No major change observed since last visit; 1 inch fissure cracks developing on the slope; rip rap is showing signs of sloughing; recommend as local maintenance issue; site was previously rated "U".

2008: No change from previous year; irrigation outlet located on site; rip rap placed on river bank.
 09/06/2007: Near agricultural diversion; only 3' landside height differential. [2015 Site ID:RD2031U01RM0.48]

Looking down at the site.

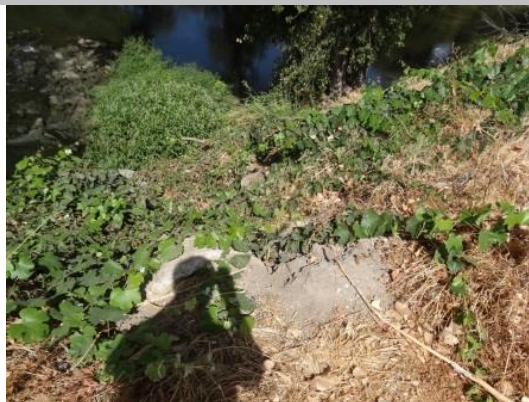
Photo 2 of 3 : SP_2016_RD2031_307_1_20160229_00002.jpg

View of the current condition of the bank slope just above the irrigation outlet.

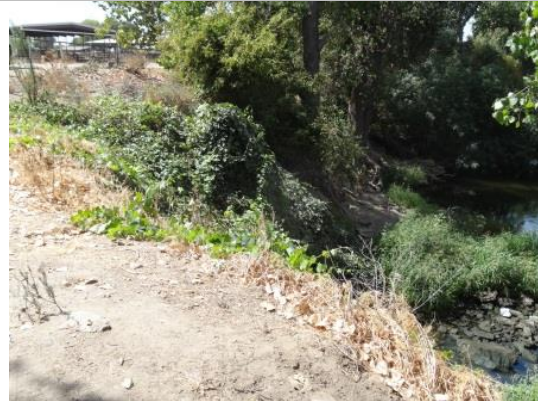
Photo 3 of 3 : SP_2016_RD2031_307_1_20160229_00003.jpg

View of the loose material at the bank top.

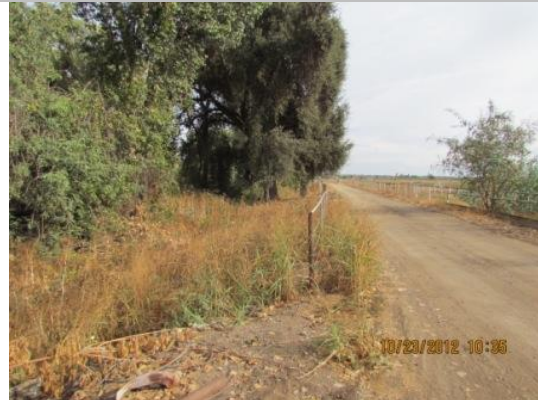
Photo 1 of 2 : SP_2016_RD2031_307_2_20160229_00004.jpg

LM Start	0.48	Rating **	M	Issue No.	2
LM End	0.51	Issue Type +	Ma	Location *	WS
Category	Earthen Levee			GPS Latitude/Longitude	
				Start	End
Item	Vegetation			37.704385 °	37.704050 °
				-121.159217 °	-121.159578 °
DWR ID	DWR_RD2031_01_s_2012_2				
Comment Code					
V2 : Remove the wild growth other than native grasses from the levee slopes.					
Inspector Comment					
Remove vegetation 20 feet away from the levee crown.

View of vegetation on waterside slope. Facing upstream.

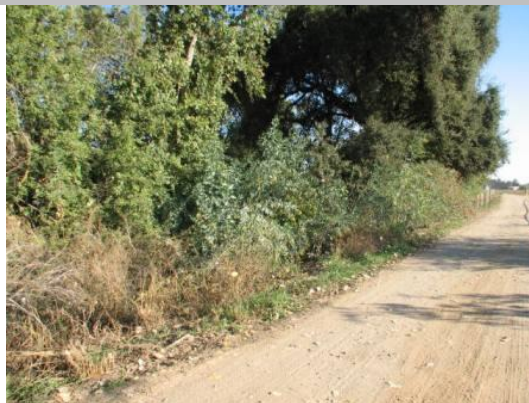
Photo 2 of 2 : SP_2016_RD2031_307_2_20160229_00005.jpg

10/26/2011 Updated photo of waterside vegetation.

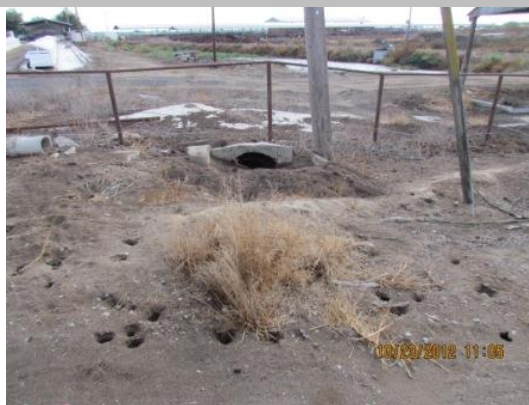
Photo 1 of 1 : SP_2016_RD2031_307_36_20160229_00018.jpg

LM Start	0.77	Rating **	M	Issue No.	36
LM End	0.77	Issue Type +	Ma	Location *	LS
Category	Earthen Levee			GPS Latitude/Longitude	
				Start	End
Item	Animal Control			37.701177 °	37.701177 °
				-121.162055 °	-121.162055 °
DWR ID	DWR_RD2031_01_f_2012_36				
Comment Code					
A3 : No rodents visible, but rodent burrows visible; need to backfill and compact or grout burrows.					
Inspector Comment

View of rodent burrows on landside slope.

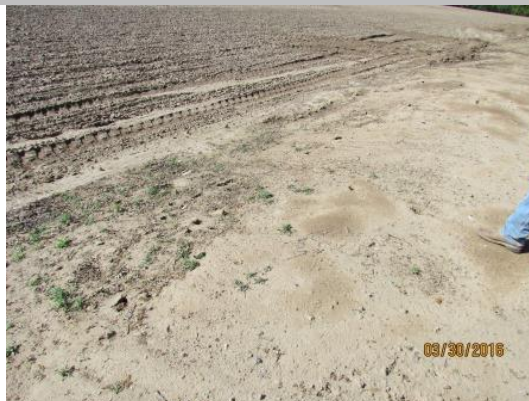
Photo 1 of 2 : SP_2016_RD2031_307_59_20160412_00081.jpg

LM Start	1.00	Rating **	M	Issue No.	59
LM End	1.00	Issue Type +	Ma	Location *	LS
Category	Earthen Levee			GPS Latitude/Longitude	
				Start	End
Item	Animal Control			37.699327 °	37.699327 °
				-121.165364 °	-121.165364 °
DWR ID	DWR_RD2031_01_f_2014_59				
Comment Code					
A3 : No rodents visible, but rodent burrows visible; need to backfill and compact or grout burrows.					
Inspector Comment

View of the multiple rodent holes on the landside levee slope.

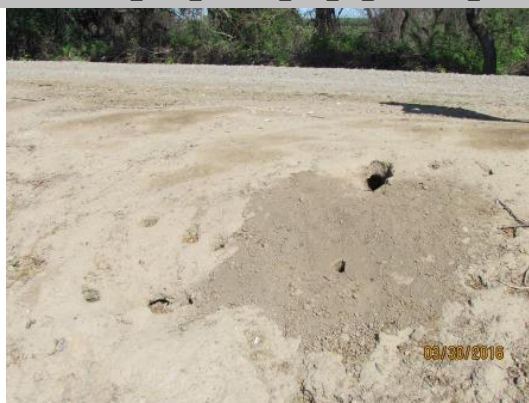
Photo 2 of 2 : SP_2016_RD2031_307_59_20160412_00082.jpg

Another view of the rodent hole on the landside levee slope.

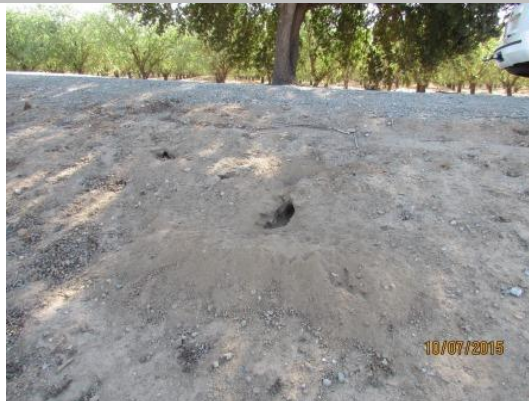
Photo 1 of 1 : SP_2016_RD2031_307_54_20160229_00029.jpg

LM Start	1.49	Rating **	M	Issue No.	54
LM End	1.49	Issue Type +	Ma	Location *	WS
Category	Earthen Levee			GPS Latitude/Longitude	
				Start	End
Item	Animal Control			37.699554 °	37.699554 °
				-121.173417 °	-121.173417 °
DWR ID	DWR_RD2031_01_f_2015_54				
Comment Code					
A1 : Exterminate rodents and backfill and compact or grout burrows.					
Inspector Comment

View of the multiple rodent holes on the waterside levee slope.

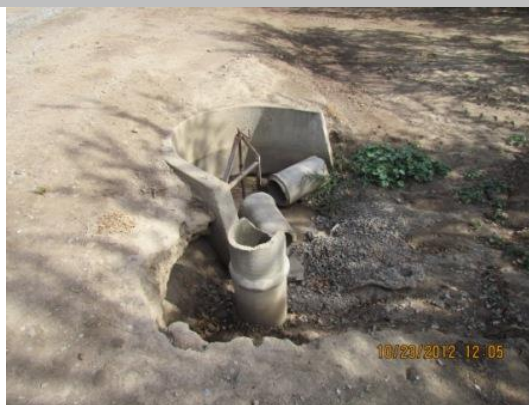
Photo 1 of 2 : SP_2016_RD2031_307_3_20160229_00006.jpg

LM Start	1.56	Rating **	U	Issue No.	3
LM End	1.56	Issue Type +	Ma	Location *	LS
Category	Earthen Levee			GPS Latitude/Longitude	
				Start	End
Item	Erosion / Bank Caving			37.698776 °	37.698776 °
				-121.174327 °	-121.174327 °
DWR ID	DWR_RD2031_01_s_2012_3				
Comment Code					
E1 : Note and monitor erosion site.					
Inspector Comment					
Erosion is active around the irrigation standpipe.

View of the erosion site on landside slope, facing upstream.

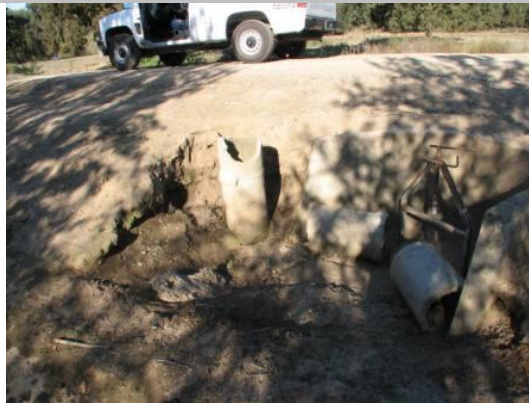
Photo 2 of 2 : SP_2016_RD2031_307_3_20160229_00007.jpg

10/26/2011 Active erosion into the levee prism around irrigation standpipe.

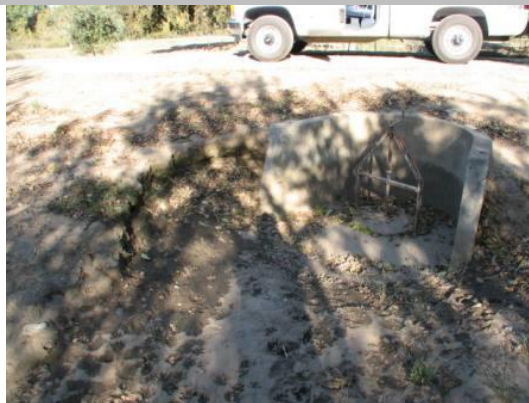
Photo 1 of 1 : SP_2016_RD2031_307_8_20160229_00012.jpg

LM Start	1.58	Rating **	U	Issue No.	8
LM End	1.58	Issue Type +	Ma	Location *	WS
Category	Earthen Levee			GPS Latitude/Longitude	
				Start	End
Item	Erosion / Bank Caving			37.698610 °	37.698610 °
				-121.174598 °	-121.174598 °
DWR ID	DWR_RD2031_01_s_2012_8				
Comment Code					
E1 : Note and monitor erosion site.					
Inspector Comment					
Active erosion is occurring around irrigation inlet.

10/26/2011 Active erosion shown around irrigation inlet.

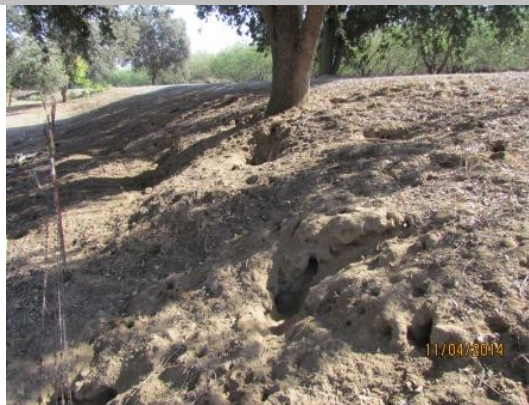
Photo 1 of 2 : SP_2016_RD2031_307_52_20160229_00026.jpg

LM Start	1.62	Rating **	U	Issue No.	52
LM End	1.62	Issue Type +	Ma	Location *	WS
Category	Earthen Levee			GPS Latitude/Longitude	
				Start	End
Item	Animal Control			37.698334 °	37.698334 °
				-121.175176 °	-121.175176 °
DWR ID	DWR_RD2031_01_f_2013_52				
Comment Code					
A3 : No rodents visible, but rodent burrows visible; need to backfill and compact or grout burrows.					
Inspector Comment

View of the multiple large rodent hole in the waterside levee slope.

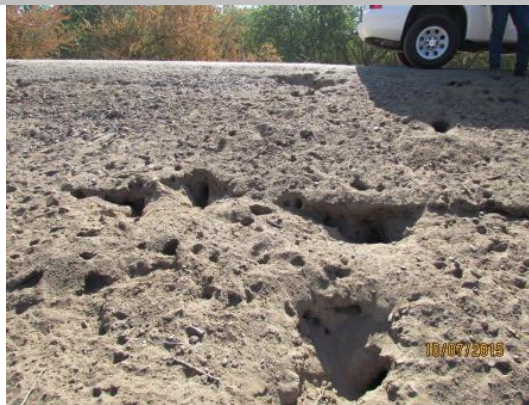
Photo 2 of 2 : SP_2016_RD2031_307_52_20160229_00027.jpg

Another view of the rodent holes on the waterside levee slope.

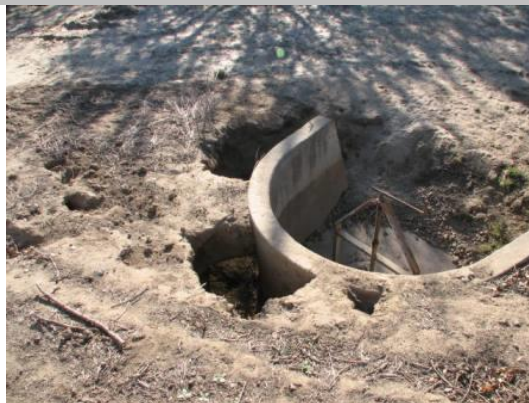
Photo 1 of 1 : SP_2016_RD2031_307_9_20160229_00013.jpg

LM Start	1.63	Rating **	U	Issue No.	9
LM End	1.63	Issue Type +	Ma	Location *	LS
Category	Earthen Levee			GPS Latitude/Longitude	
				Start	End
Item	Erosion / Bank Caving			37.698208 °	37.698208 °
				-121.175400 °	-121.175400 °
DWR ID	DWR_RD2031_01_s _ 2012_9				
Comment Code					
E1 : Note and monitor erosion site.					
Inspector Comment					
Active erosion around irrigation inlet in levee prism.

10/26/2011 Active erosion into levee prism around irrigation inlet.

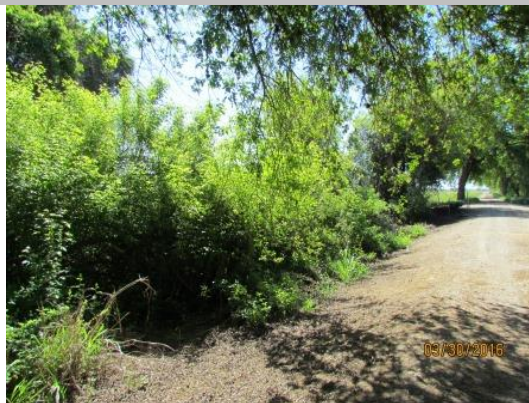
Photo 1 of 1 : SP_2016_RD2031_307_29_20160412_00083.jpg

LM Start	1.84	Rating **	U	Issue No.	29
LM End	1.84	Issue Type +	Ma	Location *	LS
Category	Earthen Levee			GPS Latitude/Longitude	
				Start	End
Item	Vegetation			37.696121 °	37.696121 °
				-121.177532 °	-121.177532 °
DWR ID	DWR_RD2031_01_s _ 2016_29				
Comment Code					
V2 : Remove the wild growth other than native grasses from the levee slopes.					
Inspector Comment

View of the tall vegetation on the landside levee slope.

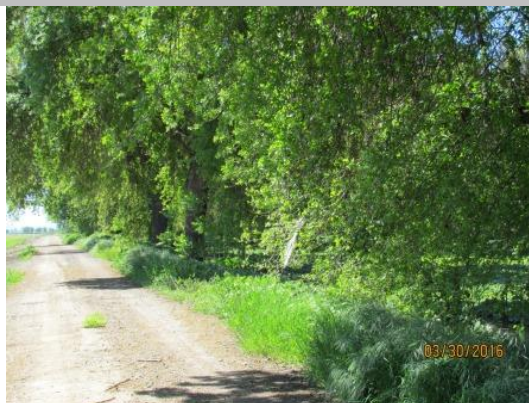
Photo 1 of 1 : SP_2016_RD2031_307_30_20160412_00084.jpg

LM Start	1.89	Rating **	M	Issue No.	30
LM End	2.17	Issue Type +	Ma	Location *	WS
Category	Earthen Levee			GPS Latitude/Longitude	
				Start	End
Item	Vegetation			37.695346 °	37.691396 °
				-121.177526 °	-121.178298 °
DWR ID	DWR_RD2031_01_s _ 2016_30				
Comment Code					
V1 : Control annual grass and weeds on the levee slopes and easements.					
Inspector Comment

View of the vegetation on the waterside levee slope.

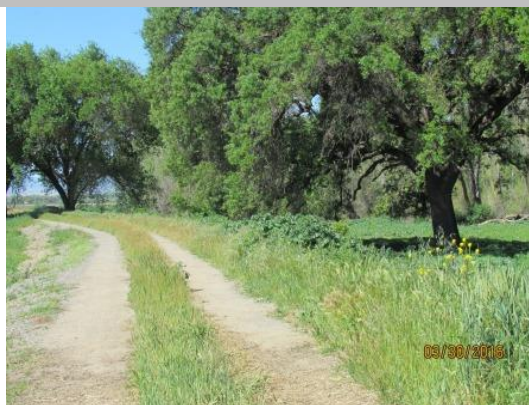
Photo 1 of 1 : SP_2016_RD2031_307_31_20160412_00086.jpg

LM Start	2.62	Rating **	M	Issue No.	31
LM End	3.51	Issue Type +	Ma	Location *	WS
Category	Earthen Levee			GPS Latitude/Longitude	
				Start	End
Item	Vegetation			37.687141 °	37.690848 °
				-121.183150 °	-121.196022 °
DWR ID	DWR_RD2031_01_s _ 2016_31				
Comment Code					
V1 : Control annual grass and weeds on the levee slopes and easements.					
Inspector Comment

View of the tall vegetation on the waterside levee slope.

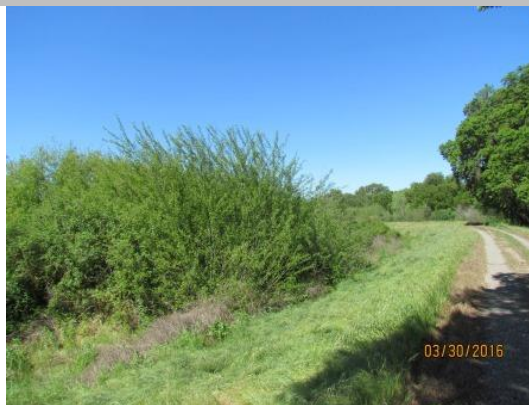
Photo 1 of 3 : SP_2016_RD2031_307_33_20160412_00088.jpg

LM Start	3.74	Rating **	U	Issue No.	33
LM End	4.25	Issue Type +	Ma	Location *	LS
Category	Earthen Levee			GPS Latitude/Longitude	
				Start	End
Item	Vegetation			37.689857 °	37.687689 °
				-121.199746 °	-121.205726 °
DWR ID	DWR_RD2031_01_s _ 2016_33				
Comment Code					
V2 : Remove the wild growth other than native grasses from the levee slopes.					
Inspector Comment					
Trim back woody vegetation at least 15 feet away from the landside levee toe.

View of the tall vegetation on the landside levee slope and toe.

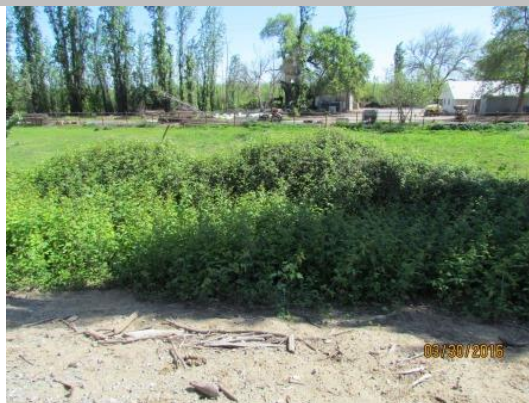
Photo 1 of 1 : SP_2016_RD2031_307_43_20160412_00090.jpg

LM Start	4.52	Rating **	U	Issue No.	43
LM End	4.52	Issue Type +	Ma	Location *	LS
Category	Earthen Levee			GPS Latitude/Longitude	
				Start	End
Item	Vegetation			37.684988 °	37.684988 °
				-121.208366 °	-121.208366 °
DWR ID	DWR_RD2031_01_s _ 2016_43				
Comment Code					
V2 : Remove the wild growth other than native grasses from the levee slopes.					
Inspector Comment

View of the tall vegetation on the landside levee slope and toe.

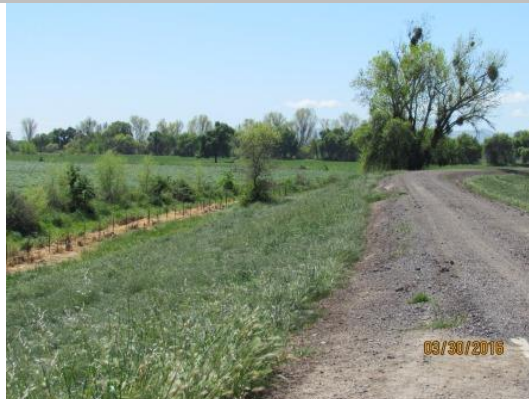
Photo 1 of 1 : SP_2016_RD2031_307_44_20160412_00091.jpg

LM Start	5.56	Rating **	M	Issue No.	44
LM End	7.08	Issue Type +	Ma	Location *	LS
Category	Earthen Levee			GPS Latitude/Longitude	
				Start	End
Item	Vegetation			37.674554 °	37.661813 °
				-121.217494 °	-121.232972 °
DWR ID	DWR_RD2031_01_s_2016_44				
Comment Code					
V1 : Control annual grass and weeds on the levee slopes and easements.					
Inspector Comment

View of the tall vegetation on the landside levee slope.

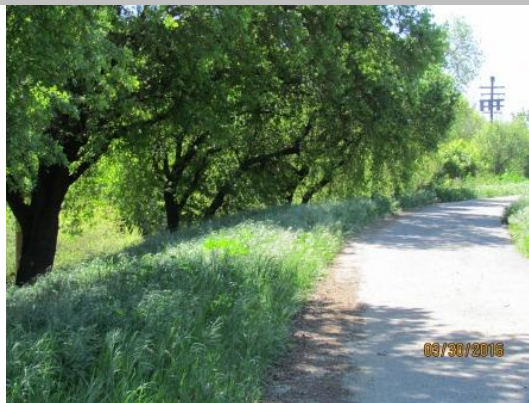
Photo 1 of 1 : SP_2016_RD2031_308_16_20160412_00033.jpg

LM Start	0.14	Rating **	M	Issue No.	16	
LM End	1.31	Issue Type +	Ma	Location *	LS	
Category	Earthen Levee			GPS Latitude/Longitude		
				Start		End
Item	Vegetation			37.659938 °		37.649387 °
				-121.233829 °		-121.221753 °
DWR ID	DWR_RD2031_02_s_2016_16					
Comment Code						
V1 : Control annual grass and weeds on the levee slopes and easements.						
Inspector Comment

View of the tall vegetation on the landside levee slope.

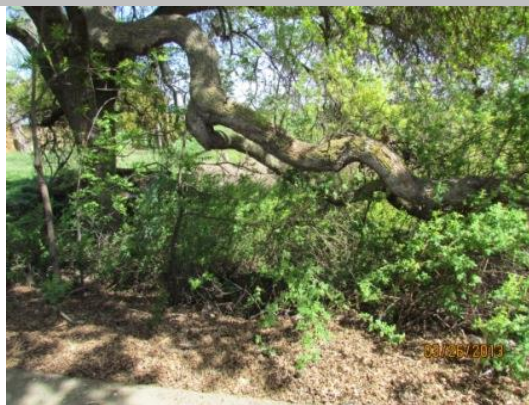
Photo 1 of 1 : SP_2016_RD2031_308_15_20160229_00006.jpg

LM Start	1.41	Rating **	M	Issue No.	15
LM End	1.41	Issue Type +	Ma	Location *	LS
Category	Earthen Levee			GPS Latitude/Longitude	
				Start	End
Item	Trim / Thin Trees			37.648080 °	37.648080 °
				-121.221031 °	-121.221031 °
DWR ID	DWR_RD2031_02_s_2013_15				
Comment Code					
T1 : Trim trees to at least five feet above ground level.					
Inspector Comment

View of the tree limb obstructing visibility and access to the landside levee slope.

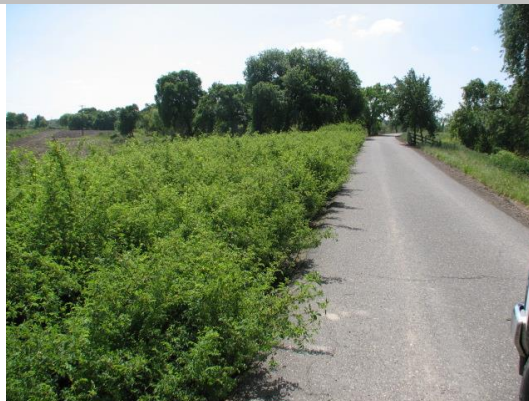
Photo 1 of 1 : SP_2016_RD2031_308_965_20160229_00010.jpg

LM Start	1.42	Rating **	U	Issue No.	965
LM End	1.46	Issue Type +	Ma	Location *	LS
Category	Earthen Levee			GPS Latitude/Longitude	
				Start	End
Item	Vegetation			37.648005 °	37.647476 °
				-121.221039 °	-121.220766 °
DWR ID	DWR_RD2031_02_s_2012_965				
Comment Code					
V2 : Remove the wild growth other than native grasses from the levee slopes.					
Inspector Comment					
Wild rose bush on landside slope.

Wild rose on levee slope.

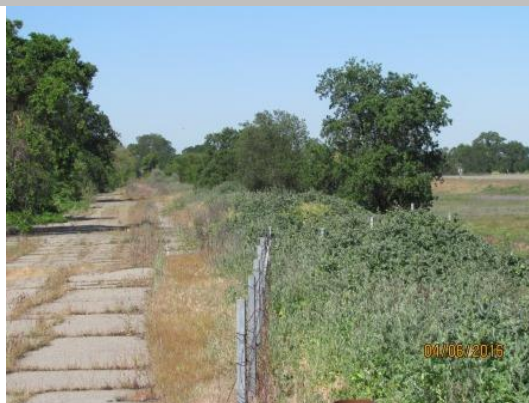
Photo 1 of 1 : SP_2016_RD2031_308_18_20160412_00034.jpg

LM Start	2.00	Rating **	U	Issue No.	18
LM End	2.34	Issue Type +	Ma	Location *	LS
Category	Earthen Levee			GPS Latitude/Longitude	
				Start	End
Item	Vegetation			37.640925 °	37.640236 °
				-121.224002 °	-121.217866 °
DWR ID	DWR_RD2031_02_s_2016_18				
Comment Code					
V1 : Control annual grass and weeds on the levee slopes and easements.					
Inspector Comment

View of the tall vegetation on the landside levee slope.

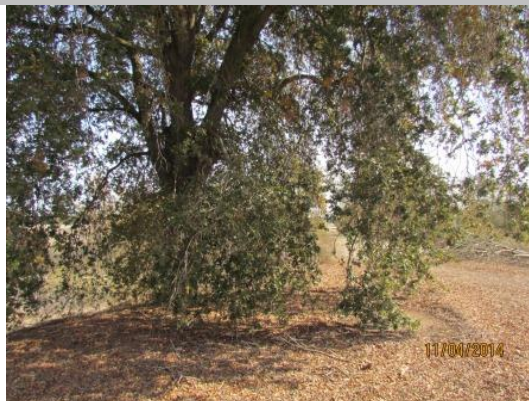
Photo 1 of 1 : SP_2016_RD2031_308_25_20160229_00008.jpg

LM Start	2.01	Rating **	M	Issue No.	25
LM End	2.01	Issue Type +	Ma	Location *	LS
Category	Earthen Levee			GPS Latitude/Longitude	
				Start	End
Item	Trim / Thin Trees			37.640874 °	37.640874 °
				-121.223870 °	-121.223870 °
DWR ID	DWR_RD2031_02_f_2014_25				
Comment Code					
T1 : Trim trees to at least five feet above ground level.					
Inspector Comment

View of the overgrown tree obstructing visibility and access of the landside levee slope.

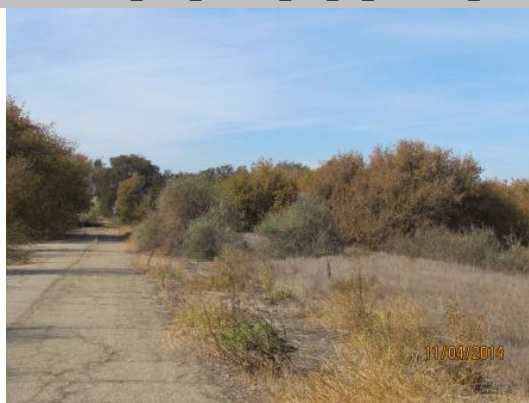
Photo 1 of 1 : SP_2016_RD2031_308_21_20160229_00007.jpg

LM Start	2.14	Rating **	M	Issue No.	21
LM End	2.14	Issue Type +	Ma	Location *	CR
Category	Earthen Levee			GPS Latitude/Longitude	
				Start	End
Item	Vegetation			37.640632 °	37.640632 °
				-121.221539 °	-121.221539 °
DWR ID	DWR_RD2031_02_f_2014_21				
Comment Code					
V2 : Remove the wild growth other than native grasses from the levee slopes.					
Inspector Comment

View of overgrown vegetation on the levee crown.

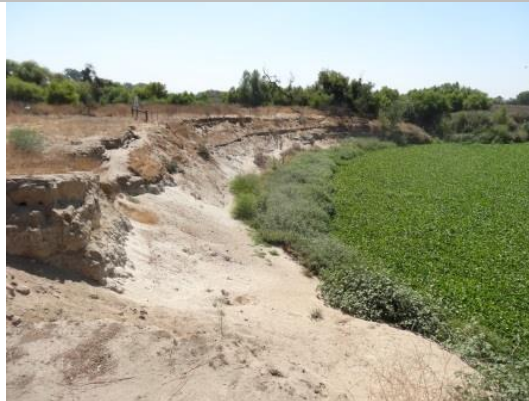
Photo 1 of 3 : SP_2016_RD2031_308_1_20160229_00001.jpg

08/19/2015: No significant change observed.
 7/17/2014: The erosion has slightly expanded toward levee toe at two pocket locations.
 09/10/2013: The site has been visited. The erosion has expanded toward levee crest at two pocket locations.
 07/18/2012: No significant change observed on the site.
 08/18/2011: No significant change observed on the site. Dead trees and animal activities are visible. The closest point of the erosion site to the levee toe is about 100 ft.
 10/19/2010: There is active scouring occurring on the bank due to the nature of the flow and the lack of armor protection. There is also a fallen log immediately downstream of where the erosion has occurred and is protruding outward, possibly creating an eddy and scouring the bank. With the remaining 100-foot wide berm, the levee prism is not yet affected. However, the bank will continue to degrade, and eventually intrude into the levee prism if no protection is put in place. Erosion site is recommended for annual assessment and monitoring during flood events. [2015 Site ID:RD2031U02RM78.7]

Looking downstream.

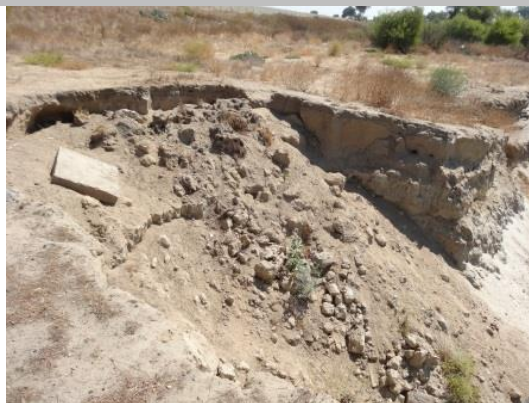
Photo 2 of 3 : SP_2016_RD2031_308_1_20160229_00002.jpg

Close view of the pocket erosion.

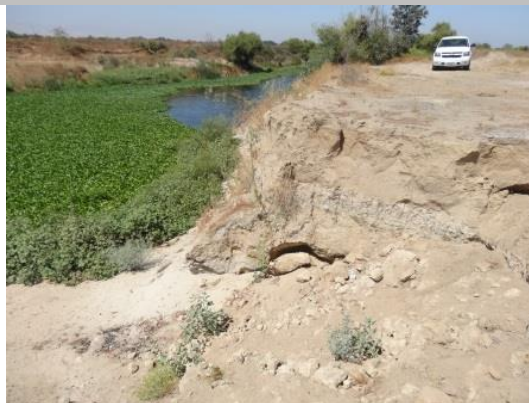
Photo 3 of 3 : SP_2016_RD2031_308_1_20160229_00003.jpg

Item	DWR Erosion Survey			37.631716°	37.631716°	
				-121.189370°	-121.189370°	
DWR ID	DWR_RD2031_02_s_2016_1					
Comment Code						
Inspector Comment						
08/19/2015: No significant change observed. 7/17/2014: The erosion has slightly expanded toward levee toe at two pocket locations. 09/10/2013: The site has been visited. The erosion has expanded toward levee crest at two pocket locations. 07/18/2012: No significant change observed on the site. 08/18/2011: No significant change observed on the site. Dead trees and animal activities are visible. The closest point of the erosion site to the levee toe is about 100 ft. 10/19/2010: There is active scouring occurring on the bank due to the nature of the flow and the lack of armor protection. There is also a fallen log immediately downstream of where the erosion has occurred and is protruding outward, possibly creating an eddy and scouring the bank. With the remaining 100-foot wide berm, the levee prism is not yet affected. However, the bank will continue to degrade, and eventually intrude into the levee prism if no protection is put in place. Erosion site is recommended for annual assessment and monitoring during flood events. [2015 Site ID:RD2031U02RM78.7]

Looking upstream. Note the pocket erosion.
